Unfinished brass "shells" from the River Avon, Bath.

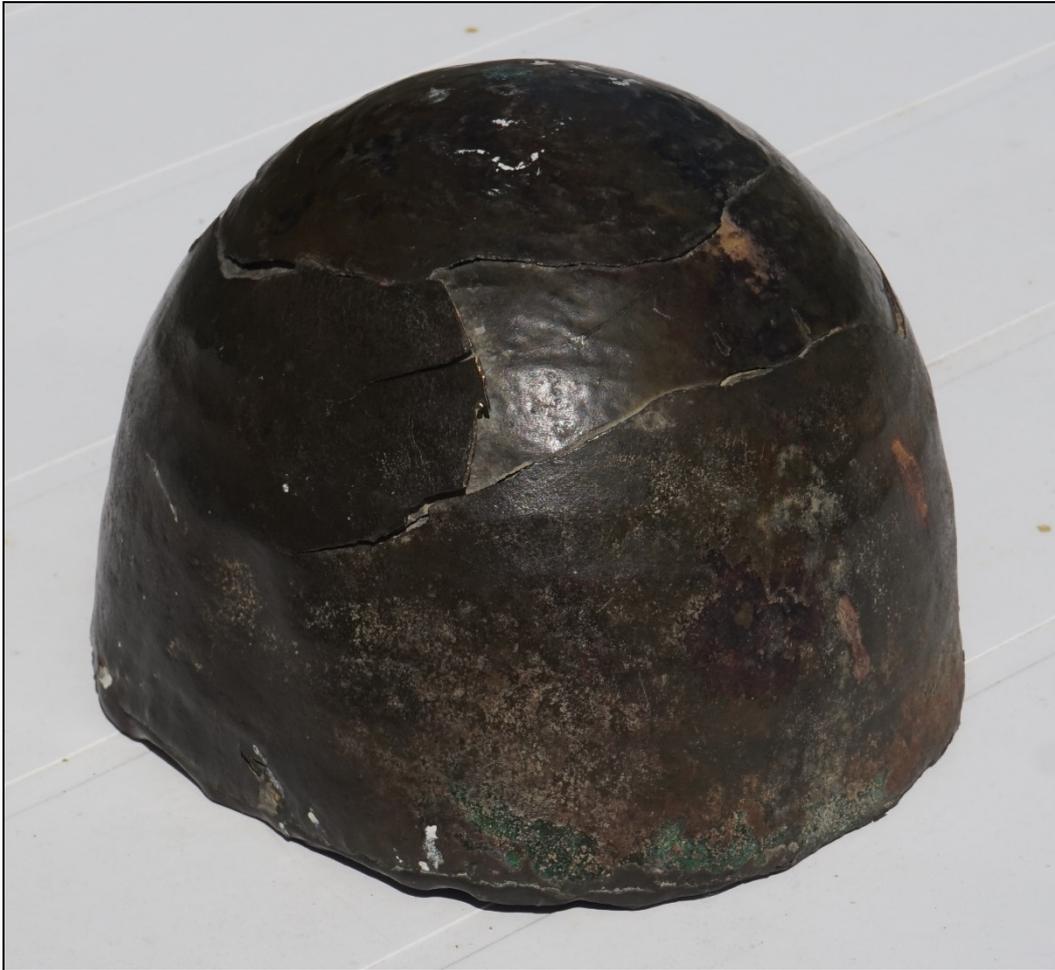
Fig. 1 An upturned set of three damaged bowls (18cm dia.) hammered together, as sometimes described in battery mill literature. These were recovered from the River Avon, down river of the Weston, Bath brass-mill site by Mr R Macy, formerly a river board man.

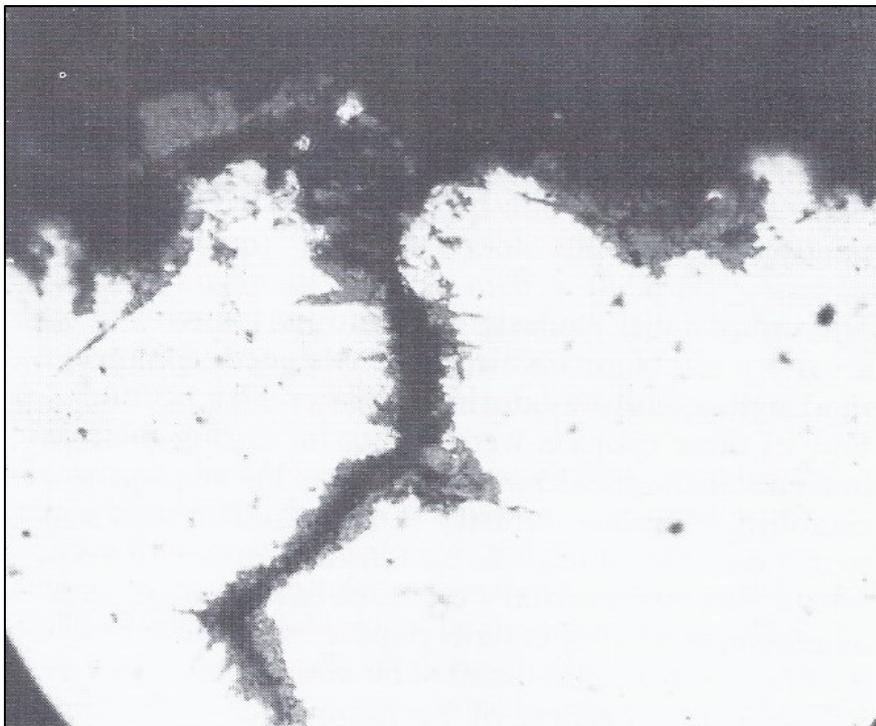
A section was cut near a broken edge and mounted and polished in the usual way. When viewed after polishing and before etching it showed a large number of smaller cracks and some signs of the 2% lead (small black spots) (Fig. 2). Etching in ferric chloride showed the expected worked and annealed structure with bent twins and some slip bands near the surface. The hardness is only 112 HVI which indicates that it is not in a highly worked state. The grain size is large which shows that it had been worked only slightly before the last anneal, or had been annealed at too high a temperature. The metal is very clean, showing no signs of the sort of slag one finds in brass pins. The iron content must be low and the fact that it is not magnetic show that it must be less than 1%. I would put it much lower than this. (Craddock gives 0.06%).

If the zinc content is 30% then it is not in a highly cold-worked state which would have a hardness of at least 145 HV after only 30% reduction. Therefore, it is clear that cracking was not caused by overworking. There remain three other possibilities: fire-cracking, stress-corrosion cracking, or cracking in the river due to oxide penetration along grain boundaries. This latter is often Called

"jacking" and is due to the stresses caused by the volume increase of the metal under corrosion (Cu to Cu_2O etc.). Fire-cracking occurs when coldworked brass is heated too rapidly annealing so that thermal stresses are imposed on those already present due to cold work; this is favoured by impurities such as lead.

In stress corrosion cracking the two most likely chemicals are ammonia from the stables and moist sulphur dioxide from the annealing furnaces. Before one can judge which is the most likely of the three possibilities one would like to know if there is any historical record which shows how common this sort of failure was. It would have occurred after cold working, before, or during annealing. Where were the shells left while they were waiting to be annealed?

I think that fire-cracking is the most likely explanation and will account best for the thick film down the crack shown in Fig. 2.

Fig. 2 Fire-crack in brass bowl (unetched) x 400.
